**Re: SSD 10272349 - Yiribana Logistics Estate**

**Environmental Representative: Monthly Report (ERMR #16)**

**SSD 10272349 - Yiribana Logistics Estate:**  
**Environmental Representative Monthly Report (ERM # 16)**  
**For the period 1 November 2025 to 30 November 2025.**

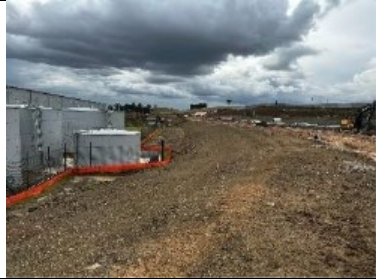
| Photo | Location and comment | Resolution/Action |
|---|---|---|
| | <p><u>Embankment adjacent to Mirvac Site – 01/08/2025</u></p> <p>The work area adjacent to the Mirvac site appeared to have been competed and require stabilisation.</p> <p><b>Recommendation</b></p> <p>Install ground stabilisation as soon as practicable to minimise the risk of erosion in this area</p> | <p><b>OBSERVATION</b></p> <p><b>RISK LOW</b></p> |

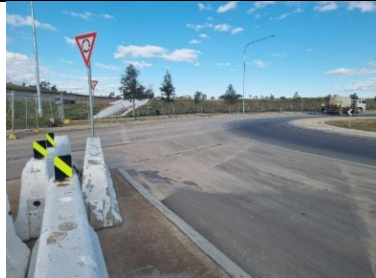
| Photo | Location and comment | Resolution/Action |
|---|---|---|
| | <p><u>Tracking from Gate to road – 23/07/2025</u></p> <p>Excessive sediment staining and tracking is occurring to the estate roadway.</p> <p>Ongoing sweeping and control are required.</p> <p><b>This is comment is to be maintained as an ongoing management priority.</b></p> | <p><b>OBSERVATION</b></p> <p><b>ONGOING</b></p> <p><b>ER Note from 10/10/2025:</b> This is comment is to be maintained as an ongoing management priority.</p> |

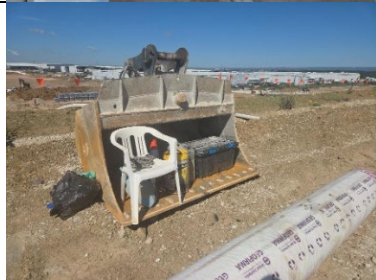
| Photo | Location and comment | Resolution/Action |
|---|---|---|
| | <p><u>Discussion – management of HCs/Fuels – 10/10/2025</u></p> <p>Fuel and HC canisters have been stored within the bucket of an excavator.</p> <p>Fuel and HC should be stored in accordance with the CEMP and guidelines.</p> | <p><b>OBSERVATION</b></p> <p><b>ONGOING</b></p> <p><b>ER Note from 05/11/2025:</b> This issue was disused previously.</p> <p>It does not appear that the bucket presents an appropriate environmental control/containment for the hydrocarbon storage.</p> <p><b>This should be discussed with the contractor and appropriate controls provided.</b></p> |

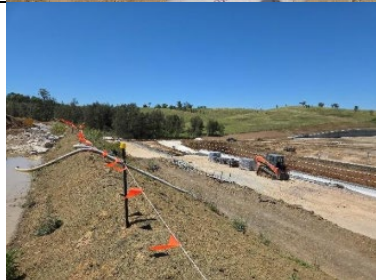
| Photo | Location and comment | Resolution/Action |
|---|---|---|
| | <p><u>Progress central channel and retaining wall works – 05/11/2025</u></p> <p>Works to the central channel are still outstanding.</p> <p>The retaining wall works are progressing – this is limiting catchments to central channel.</p> | <p><b>OBSERVATION</b></p> |

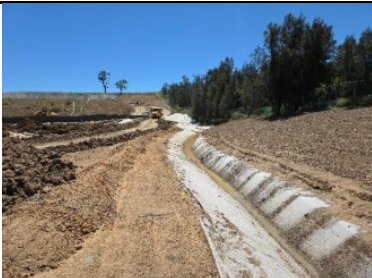
| | | <p><u>Eastern batter to channel – 05/10/2025</u></p> <p>The batter and surrounds report to the central channel via a fabric lined drain.</p> <p>This area includes the rear of the retaining wall and offsite catchments.</p> <p>While these catchments are not stabilised – these catchments need to be managed to the controls within the estate.</p> <p>It is recommended that the batter to the east is stabilised as a priority.</p> | <p><b>OBSERVATION</b></p> | |

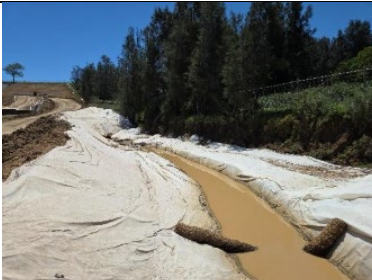
| | | <p><u>Interface with clean water channel – 05/11/2025</u></p> <p>Action is required this area.</p> <p>The water immediate to the channel should be removed by sucker truck so potential for this water to progress to the clean water drain is removed.</p> <p>A bund or appropriate large control should be maintained to prevent the catchments from the south reporting to this area.</p> <p><b>Issues in this area have been raised by the Alternate ER 27/09/25</b></p> | <p><b>Outstanding</b></p> | |

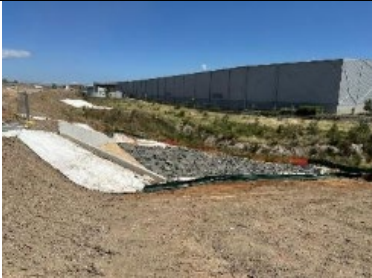
| | | <p><u>Drainage outlet to riparian zone – 24/10/2025</u></p> <p>Environmental controls at the outlet upstream of the riparian zone were in good condition.</p> <p><u>Drainage outlet to riparian zone – 24/10/2025</u></p> <p>Works are progressing at the outlet.</p> <p>The verges to the ballast are to be completed and stabilised.</p> <p>Sediment controls need to be returned to the flanks for the outlet area.</p> | <p><b>OBSERVATION</b></p> | |

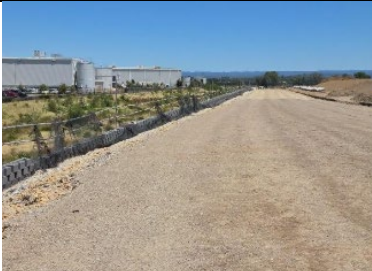
| | | <p><u>Western road to block wall – 05/11/2025</u></p> <p>The new road formation is well rolled/sealed. Drainage is directed to the side of the formation to the rear of the wall and also to the northern side.</p> <p>Heavy flows progress to the basin at the western extent. Limited flows will pass through the retaining wall.</p> <p>During rainfall monitor the volume of water passing through the wall.</p> | <p><b>OBSERVATION</b></p> | |

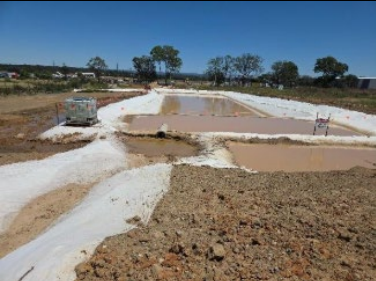
| | | <p><u>East West Basin – 05/11/2025</u></p> <p>Water within the inlet areas is turbid. Water within the forebay is turbid.</p> <p><b>This water should be treated or otherwise removed and the function of the basin reviewed by the CPESC.</b></p> | <p><b>OBSERVATION</b></p> |

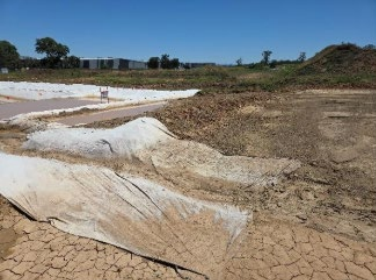
| | | <p><u>Inlet area to East West Basin – 05/11/2025</u></p> <p>Water within the inlet areas is turbid.</p> <p>Water within the forebay is turbid.</p> <p><b>This water should be treated or otherwise removed and the function of the basin reviewed by the CPESC.</b></p> | <p><b>OBSERVATION<br/>For review</b></p> |

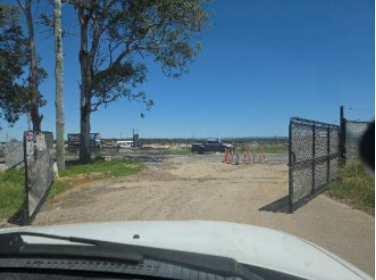
| | | <p><u>Access/Gate to Mamre Road – 05/11/2025</u></p> <p>Per previous observations.</p> <p>Water is pooling at the entrance to the development from Mamre Road.</p> <p>Drainage in this area should be improved to reduce extended tracking to Mamre Road following rainfall.</p> | <p><b>Previous Issues</b></p> |

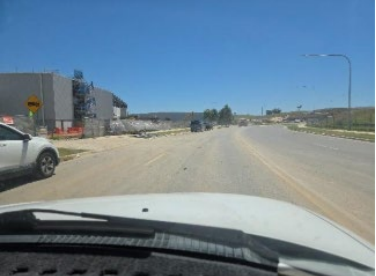
| | | <p><u>Road and tracking – observations within Aspect Industrial Estate – 05/11/2025</u></p> <p>Sediment tracking is evident over the roadways.</p> <p>The tracking is derived from multiple sources including;</p> <p>Southern development access from Access Industrial Estate</p> <ul style="list-style-type: none"> <li>• Multiple Lots within the Estate</li> <li>• Roundabout and surrounds including from the immediate access to Yiribana Development</li> </ul> | <p><b>OBSERVATION ONLY</b></p> |

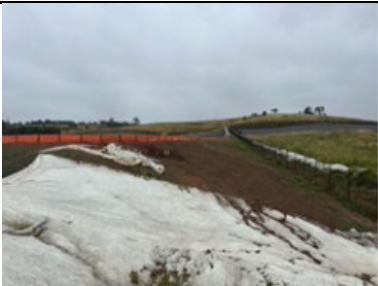
| | | <p><u>Batter adjacent to MIRVAC Boundary – 21/11/2025</u></p> <p>Geofabric ground cover has become displaced, leaving the batter exposed.</p> <p><b>Recommendation</b></p> <p>Reinstate the geofabric batter or apply polymer sealant as required</p> | <p><b>OBSERVATION</b></p> <p><b>RISK MEDIUM</b></p> | |

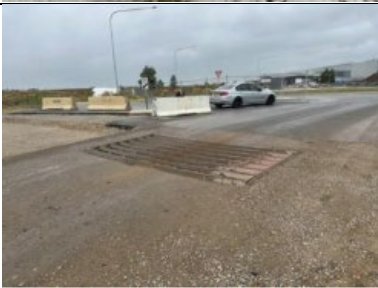
| | | <p><u>Site Access Point – 21/11/2025</u></p> <p>Mud tracking was being actively managed via rumble grid at site entrance with a streetsweeper available to clean up any residual materials</p> | <p><b>OBSERVATION</b></p> | |

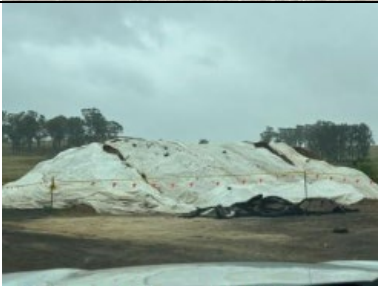
| | | <p><u>Asbestos stockpile – 21/11/2025</u></p> <p>Geofabric covering of asbestos stockpile has become displaced.</p> <p><b>Recommendation</b></p> <p>Re-instate and secure the geofabric material to ensure the asbestos stockpile is completely covered.</p> | <p><b>OBSERVATION</b></p> <p><b>RISK LOW</b></p> | |

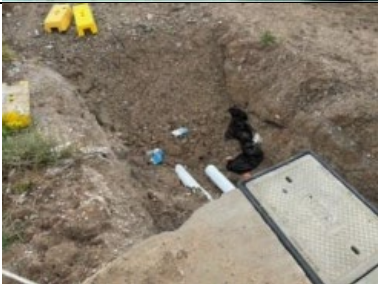
| | | <p><u>Housekeeping – 21/11/2025</u></p> <p>Housekeeping needs to be improved. Instances around the site included littering and waste materials stored outside the designated waste containers.</p> <p><b>Recommendation</b></p> <p>All rubbish and litter is to be placed in the waste containers located on site. Conduct refresher toolbox training as required. All rubbish should be removed prior to Xmas shutdown</p> | <p><b>OBSERVATION</b></p> <p><b>RISK LOW</b></p> | |

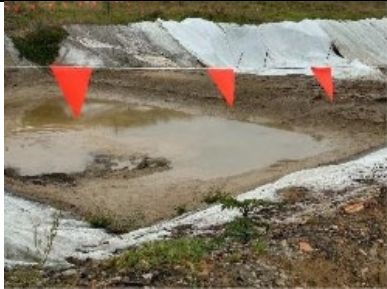
Sediment Basins -21/11/2205

Sediment basins were observed to be capturing water with accumulated sediment contained within the basins.

Repair and maintenance of geofabric basin walls is needed as well as cleanout of accumulated sediment to ensure ongoing operational effectiveness

**OBSERVATION**  
**RISK LOW**

Repair and maintain sediment basins, remove accumulated sediment on an as required basis

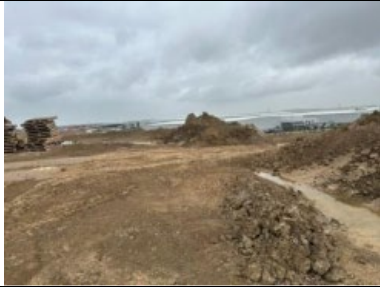
Internal Haul Road – 21/11/2025

It was noted that the temporary v drain in the location of the internal haul road had been removed and requires re-instatement.

**OBSERVATION**  
**RISK LOW**

Reinstate the v drain
