**Re: SSD 10272349 - Yiribana Logistics Estate**

**Environmental Representative: Monthly Report (ERMR #14)**

**SSD 10272349 - Yiribana Logistics Estate:**  
**Environmental Representative Monthly Report (ERMIR # 14)**  
**For the period 1 September 2025 to 30 September 2025.**

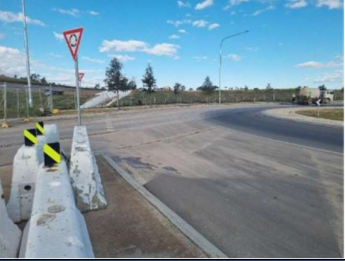
| Photo | Location and comment | Resolution/Action |
|---|---|---|
| | <p><u>Tracking from Gate to road – 23/07/2025</u></p> <p>Excessive sediment staining and tracking is occurring to the estate roadway.</p> <p>Ongoing sweeping and control are required.</p> <p><b>This is comment is to be maintained as an ongoing management priority.</b></p> | <p><b>OBSERVATION</b></p> <p><b>ONGOING</b></p> |

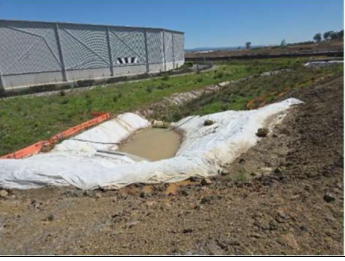
| Photo | Location and comment | Resolution/Action |
|---|---|---|
| | <p><u>Outlet from Clean water culvert – 15/09/2025</u></p> <p>This item outstanding from previous inspection – the fabric has been freshened but the sediment and controls have not been cleared.</p> <p>This will again be discussed with the ER from the southern ACCESS development.</p> | <p><b>OBSERVATION</b></p> |

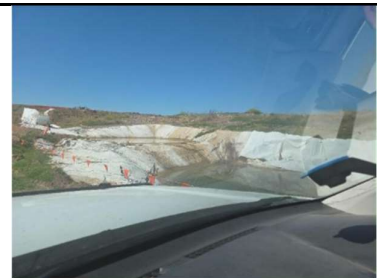
| | <p><u>Northern basin WH4 – 15/09/2025</u></p> <p>The water within the basin is clear. It was discussed that the catchments to this basin have not been completely cleared.</p> <p>Much of the exposed area is still disturbed topsoils rather than stripped to clay subsoils.</p> | <p><b>OBSERVATION</b></p> |

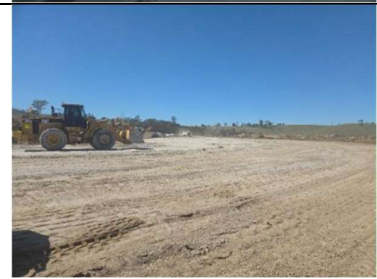
| | <p><u>Dust – 15/09/2025</u></p> <p>General management of dust was discussed. It was confirmed that there is expected to be increased focus by the Dept. on the active management of dust generating activities especially during summer conditions.</p> <p>It is re-iterated that any observations or exceedances of dust issues should include record of contributing factors such as site activities, wind conditions and mitigation measures implemented.</p> <p>This will allow for improved and demonstration of active management.</p> | <p><b>OBSERVATION</b></p> <p><b>ONGOING</b></p> |

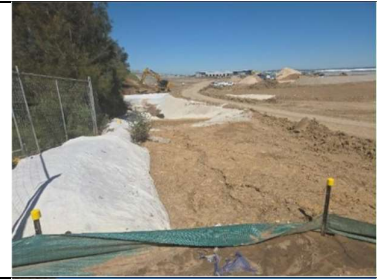
| | <p><u>Controls at eastern boundary – North side of Drain – 15/09/2025</u></p> <p>Maintenance of the sediment fence in this area is recommended.</p> <p>The lower sediment control should be cleared and the bund raised to improve its function.</p> | <p><b>OBSERVATION</b></p> <p><b>RISK MEDIUM</b></p> |

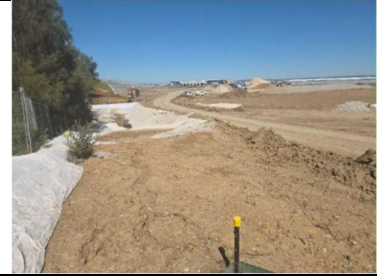
| | <p><u>Controls at eastern boundary – North side of Drain – 15/09/2025</u></p> <p>It was indicated that management currently is to direct water from the northern ramp and access area across the culvert crossing- see notes following.</p> <p>Per above comments. Maintenance of sediment controls are required to accommodate the remaining catchments that cannot be diverted across the culvert crossing to the southern catchments.</p> | <p><b>OBSERVATION</b></p> |

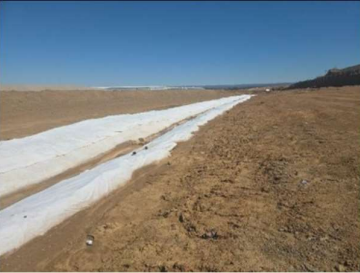
| | | <p><u>Lined clean water drain – 15/09/2025</u></p> <p>The catchments to the north of the central swale are directed by the perimeter bund to the west and to the controls adjacent to the swale.</p> <p>Note aggregate/sediment indicated within the check measures within the swale. this sediment needs to be cleared.</p> <p>It was confirmed that this separation needs to be maintained and inspected prior to rain events to confirm that water from the works does not pass to the swale.</p> <p>Note aggregate/sediment indicated within the check measures within the swale. this sediment needs to be cleared.</p> | <p><b>OBSERVATION</b></p> <p><b>ONGOING</b></p> | |

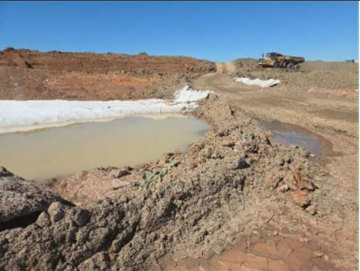
| | | <p><u>Clean water through Drain – 15/09/2025</u></p> <p>Water drains to controls either side of central swale.</p> <p>Per above, it was confirmed that this separation and side bunds need to be maintained and inspected prior to rain events to confirm that water from the works does not pass to the swale.</p> | <p><b>OBSERVATION</b></p> <p><b>ONGOING</b></p> | |

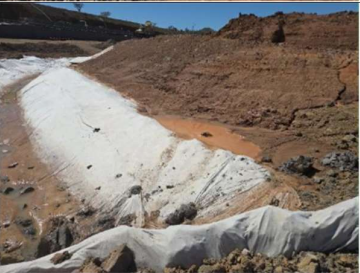
| | | <p><u>Clean water through Drain – Cont. – 15/09/2025</u></p> <p>Water drains to controls either side of central swale.</p> <p>Per above, it was confirmed that this separation and side bunds need to be maintained and inspected prior to rain events to confirm that water from the works does not pass to the swale.</p> | <p><b>OBSERVATION</b></p> <p><b>ONGOING</b></p> | |

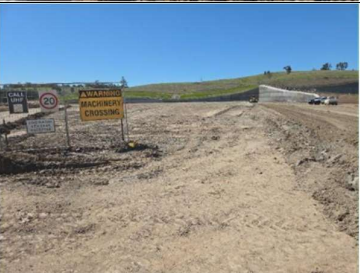
| | | <p><u>Landscaping – rear of Eastern Retaining Wall – 15/09/2025</u></p> <p>Revegetation / cover over eastern batter is progressing.</p> | <p><b>OBSERVATION</b></p> | |

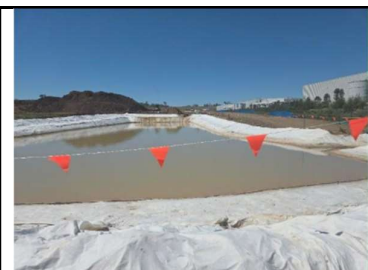
| | <p><u>Western basin (EW Basin) – 15/09/2025</u></p> <p>Observation only.</p> <p>It was raised that the outlet channel from the basin is narrow and not per as recommended by the IECA guidance.</p> <p>Performance of this basin should be monitored and regularly reviewed by CPESC to confirm need for augmentation if required.</p> | <p><b>OBSERVATION</b></p> |

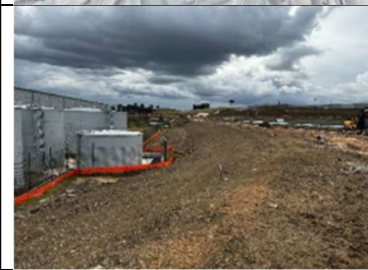
| | <p><u>Embankment adjacent to Mirvac Site – 01/08/2025</u></p> <p>The work area adjacent to the Mirvac site appeared to have been compete and require stabilisation</p> <p><b>Recommendation</b></p> <p>Install ground stabilisation as soon as practicable to minimise the risk of erosion in this area.</p> | <p><b>OBSERVATION</b></p> <p><b>RISK LOW</b></p> <p><b>STATUS – OPEN</b></p> |

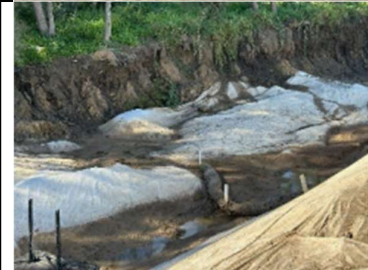
| | <p><u>Clean Water Drain Inlet (adjacent to site boundary) – 29/08/2025</u></p> <p>The inlet area to the geofabric clean water drain appeared to be a potential source of sediment with the potential to contaminate clean water drain</p> <p><b>Recommendation</b></p> <p>Review and refresh the controls in this area in consultation with the project CPESC.</p> | <p><b>OBSERVATION</b></p> <p><b>RISK MEDIUM</b></p> <p>Additional geofabric has been applied upstream of the clean water drain inlet to minimise cross contamination of the clean water drain.</p> <p><b>STATUS – CLOSED</b></p> |

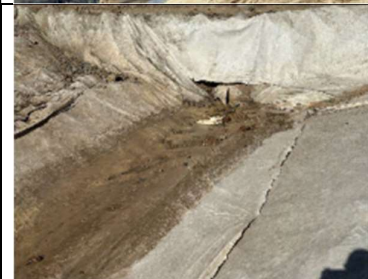
| | <p><u>Clean Water drain – 29/08/2025</u></p> <p><b>Recommendation</b></p> <p>Ongoing monitoring and maintenance of the clean water drain to ensure accumulated material does not present a hazard</p> | <p><b>OBSERVATION</b></p> <p><b>RISK MEDIUM</b></p> <p><b>ER Note:</b> the drain is planned to be removed with permanent infrastructure installed. If the installation of the permanent drain is delayed, then the clean water drain needs to be replenished to avoid any contaminated runoff into the wetland downstream from the site</p> <p><b>STATUS – OPEN</b></p> |

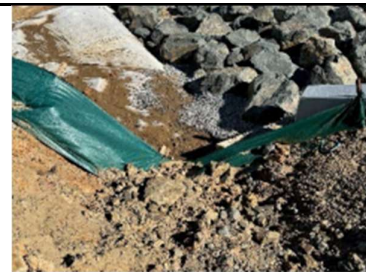
| | <p><u>Clean Water Drain Outlet (adjacent to Mirvac site boundary/ riparian zone) – 29/08/2025</u></p> <p>Sediment fence adjacent to the riparian zone had fallen and requires maintenance</p> <p><b>Recommendation</b></p> <p>Reinstate/maintain the sediment fences in this area – remove any accumulated sediment.</p> | <p><b>OBSERVATION</b></p> <p><b>RISK MEDIUM</b><br/>The sediment fence has now been repaired</p> <p><b>STATUS – CLOSED</b></p> |

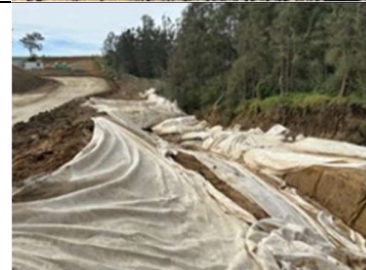
| | <p><u>Clean Water Drain Inlet (adjacent to site boundary) – 26/09/2025</u></p> <p>As recommended by the previous ER inspection (29/8) additional geofabric has been applied upstream of the clean water drain inlet to minimise cross contamination of the clean water drain.</p> | <p><b>OBSERVATION</b></p> |

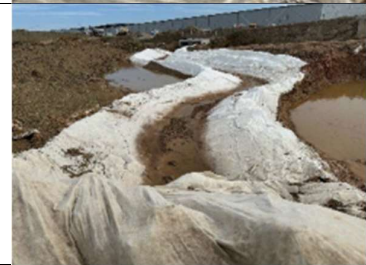
| | <p><u>Clean Water drain – 26/09/2025</u></p> <p>Clean water drain is in relatively good condition with energy dissipators /rock checks installed to reduce flow velocity. As noted in item 3, the permanent drain needs to be installed ASAP or the geofabric refreshed to avoid the potential for offsite pollution into the wetland.</p> | <p><b>OBSERVATION</b></p> |

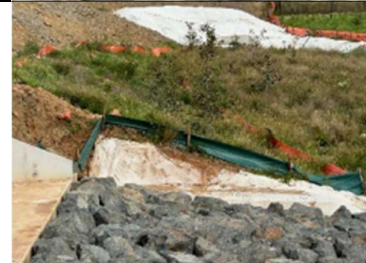
| | <p><u>Clean Water Drain Outlet (adjacent to Mirvac site boundary/ riparian zone) – 26/09/2025</u></p> <p>As recommended by the previous ER inspection (29/8) the sediment fence has now been repaired</p> | <p><b>OBSERVATION</b></p> |
