## **Deer Park Estate – 179 Tilburn Road, Deer Park**

### **Growling Grass Frog Conservation Management Strategy (GGF CMS)**

**Prepared for HB&B Property Pty Ltd,  
and GPT Platform Pty Ltd**

May 2025  
Report No. 22173.07 (1.7)

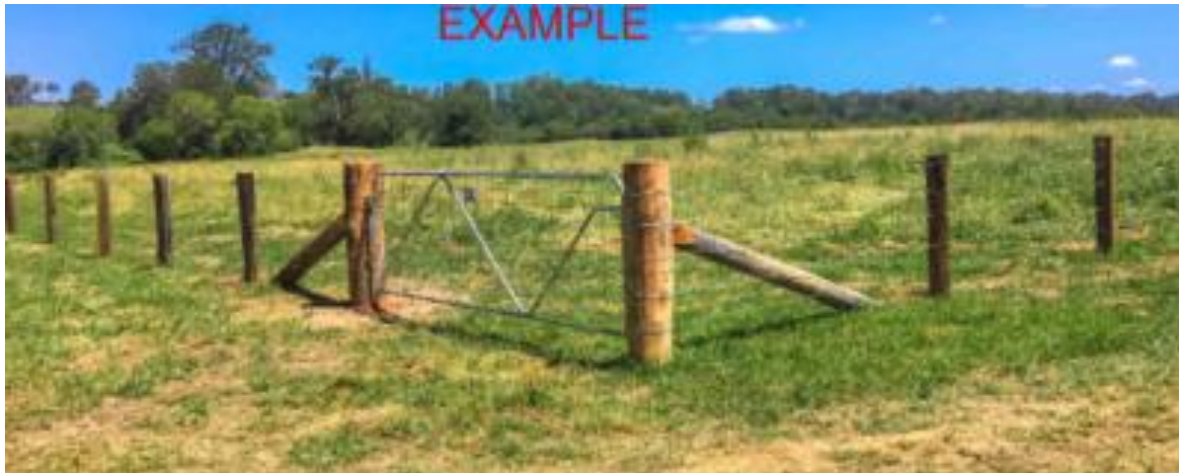
Photo 5: Example of the permanent fencing proposed for the variable Buffer zone along Kororoit Creek.

The proposed development includes the erection of a permanent rural style fencing with gates along the length of the variable buffer zone along the Kororoit Creek. This fencing will delineate the conservation area to protect the creek buffer area from access by people unnecessarily. Signage must explain the purpose and importance of the GGF buffer. This fencing design is in accordance with Western Sydney Parklands Design Manual 2020 (See example photo 5 below).
